# Condition Assessment of the

## Water Importation Mainline Pipeline

Tehachapi-Cummings County Water District

#### V 2.0 – August 2017

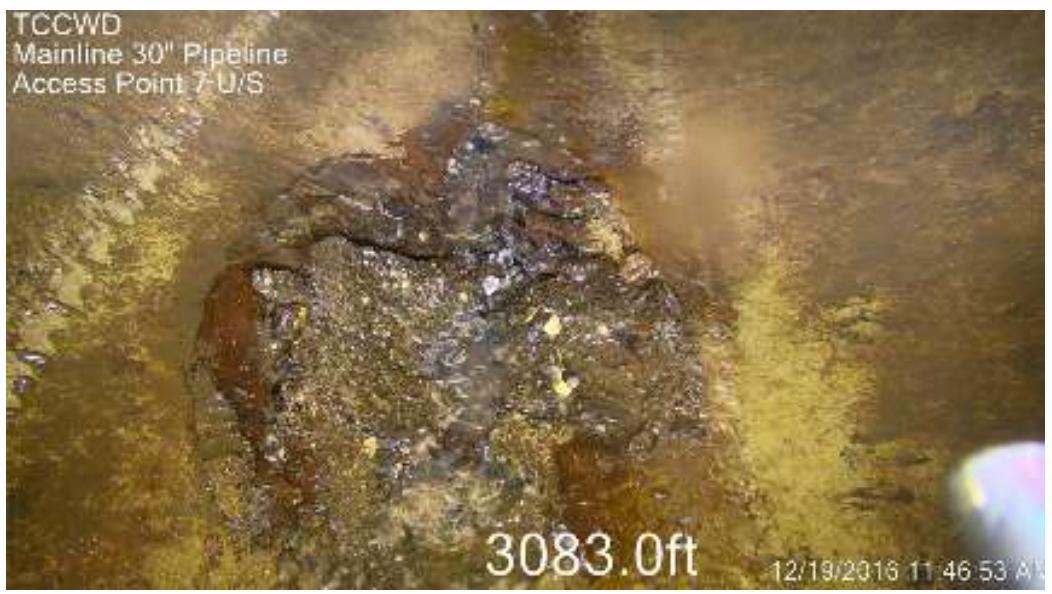
The Pure Pipe Reference Number 5155 containing a localized anomalous electromagnetic signal was observed with severe pitting of the steel cylinder collocated with the electromagnetic anomaly. Figure 2.5 shows the cylinder defect identified in Pure Reference Number 5155 located at Station 325+98.

Figure 2.5: Spalling and cylinder defect observed in Pure Reference Number 5155, Station 325+85

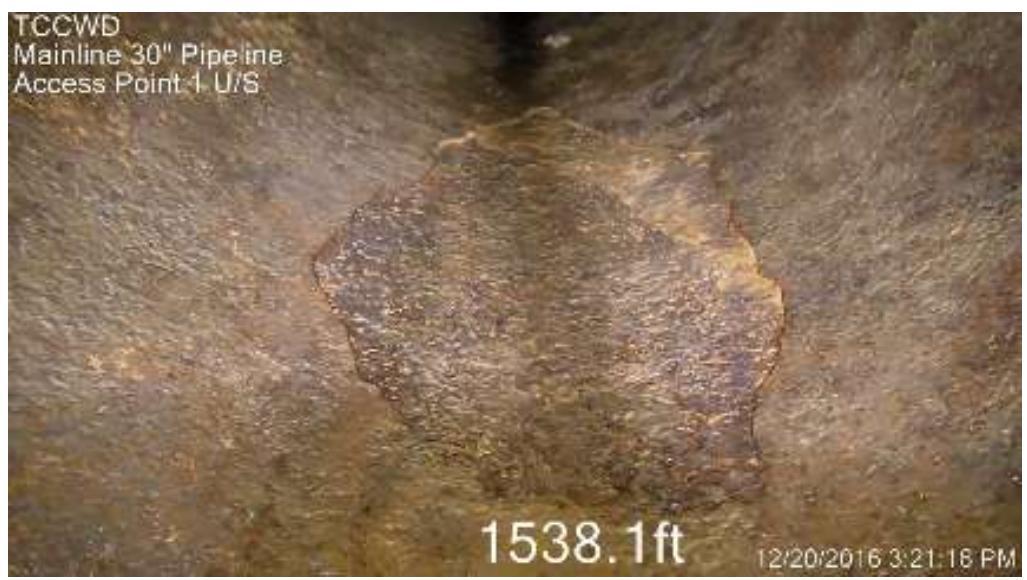
A section of spalling was observed in Pure Reference Number 1 located at approximate Station 0+25. The spalling was approximately 5 feet in length and located at the invert of the pipe. Figure 2.6 shows this spalled section of pipe.

Figure 2.6: Section of spalling, Pure Reference Number 1, Station 0+25.

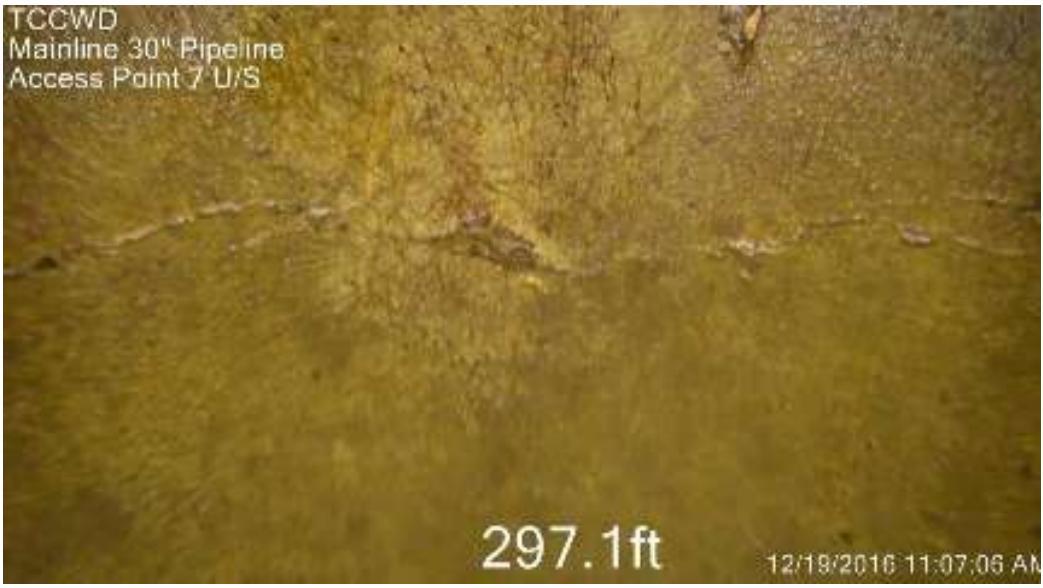
Figure 2.7 shows a typical example of circumferential cracking; this one identified in Pure Reference Number 5226 located at Station 353+40, upstream of Access 7.

Figure 2.7: Circumferential crack observed in Pure Reference Number 5226, Station 353+40

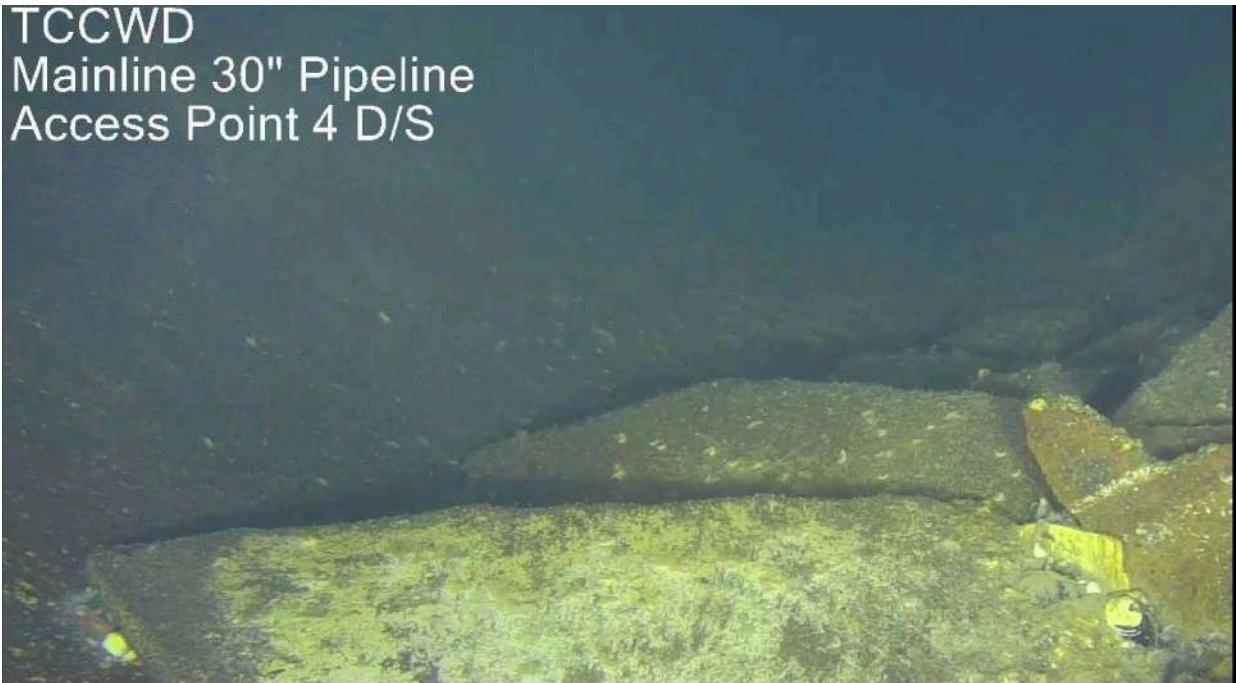
Figure 2.8 shows the largest debris pile encountered during the inspection, at Station 211+55. This location was marked above ground for immediate remedial action.

Figure 2.8: Large debris pile observed in Pure Reference Number 4080, Station 211+55 to 211+80

- Severe debris buildup located around Station 211+55 to 211+80 is reducing the hydraulic capacity of the pipeline. TCCWD should remove this debris as soon as is conveniently possible. The locations of spalled internal lining and internal cylinder corrosion should be considered for repair at TCCWDs convenience. These locations are listed in the video review in Appendix F.

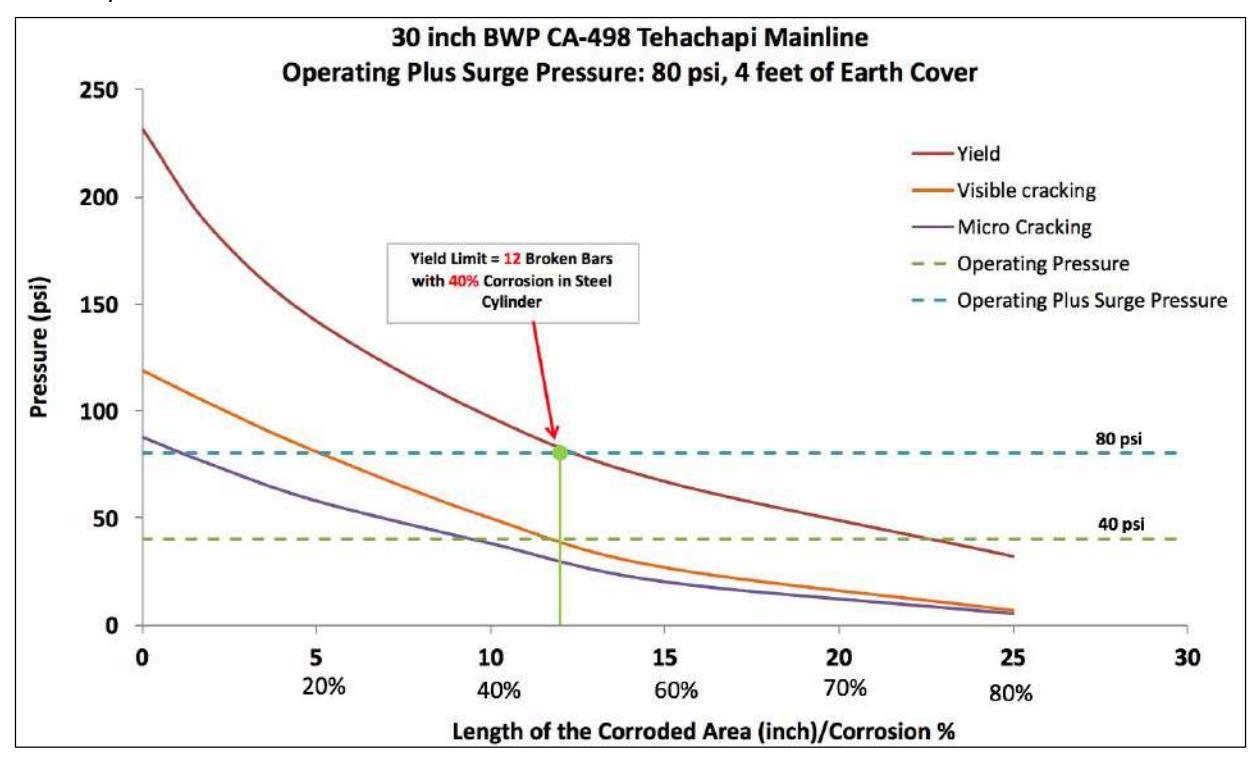
Figure 2.17: Performance curve for the 30-inch BWP pressure Class 150

Pure Pipe Reference Number 2103, the only pipe with an electromagnetic signal indicating the presence of broken pretensioned bars, had an estimate of five (5) broken bars with an assumed less than 20% cylinder wall loss. This places the pipe somewhere between the Visible Cracking and Micro Cracking Limits on the performance curve when evaluated at the maximum recorded surge pressure.

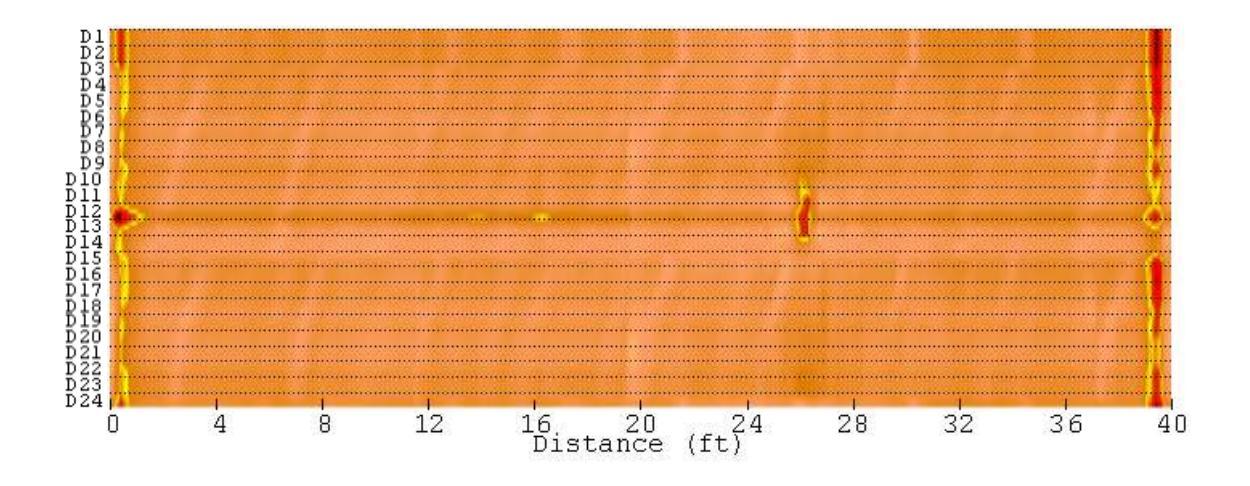
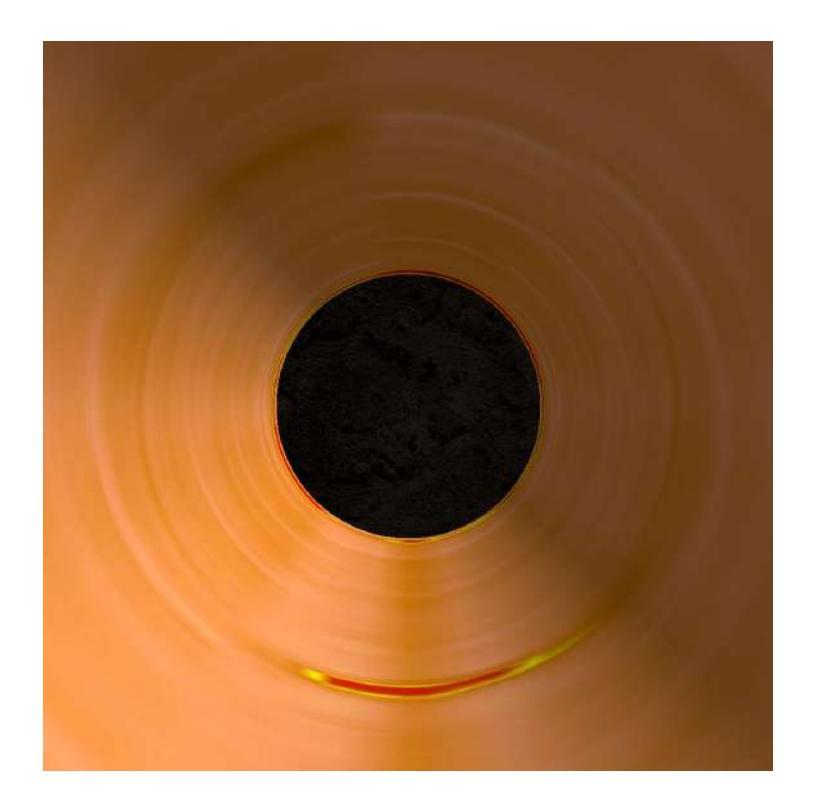
### Pure Reference Number 4012:

- 2. Three (3) pipes (0.3%) contained an anomalous electromagnetic signal not characteristic of broken bar wraps that can be attributed to a change in the pipe cylinder. Pure Pipe Reference Numbers 4012, 5122, and 5155 contained these cylinder anomalies. These observations correlated to a visual observations of severe cylinder corrosion.
